## **A Laboratory Study on the Failure of a Petroleum, Oil and Lubricant (POL) Fuel Tank**

DSTO-TN-0300

**Combatant Protection and Nutrition Branch  
Aeronautical and Maritime Research Laboratory**

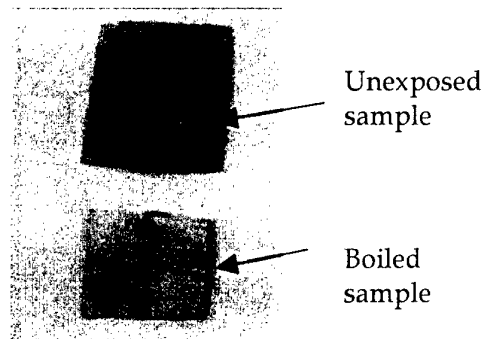
Boiling samples of the coated fabric in a sodium hydroxide solution did not degrade the coating to the same degree as observed in-service. It did have a significant impact on the colour of the coating, which changed from a light brown to grey (Figure 3). It was observed that the change of colour only occurred on the surface and did not penetrate the coating matrix.

Figure 3. Change of colour after 5 hrs boiling in a 4% aqueous sodium hydroxide solution

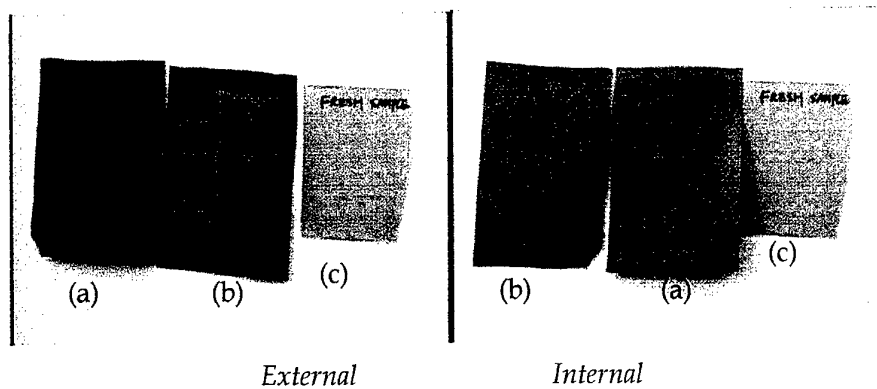
Undamaged samples and samples from undamaged areas of the POL tanks were exposed in the Xenon arc weatherometer for periods ranging from 9 weeks for the undamaged sample and 5 weeks for samples from the POL tanks. Although the samples were exposed to both Xenon light and high humidity (water spray), apart from a change in colour, they showed no evidence of degradation. As shown in Table 2, IR analysis did not indicate any significant loss of ester moiety from the coating material. Figure 5 shows the rear and front faces of the internal and external surfaces of the tank after exposure to Xenon weathering. A sample of unexposed fabric is included for comparison.

Figure 5. POL tank samples after 5 weeks Xenon light and water exposure (a) rear surface, (b) exposed surface and (c) unexposed sample

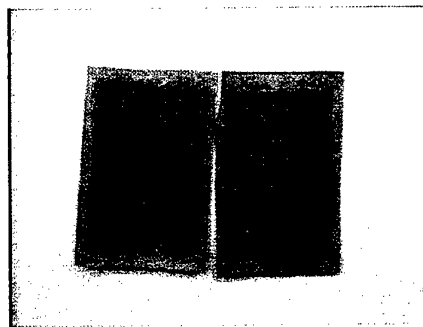
Figure 6 shows an original sample of the coated fabric after 9 weeks exposure in the Xenon arc weatherometer. As expected, apart from a change in colour, there was no other visible damage to the specimen. This was confirmed by IR analysis and is shown in Table 2.

Figure 6. Fresh coated fabric samples after 9 weeks exposure to Xenon light and water spray

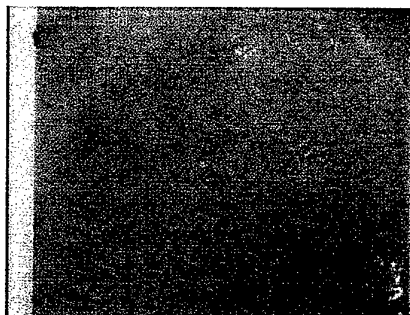
Figures 7, 8 and 9 show the samples following exposure of 4, 6 and 12 weeks respectively in the hot and humid environment within the desiccator. Figure 7 displays visual evidence of water damage and Figure 8 shows the failure of the coated samples after 6 weeks exposure. Figure 9 shows that the sample was completely degraded after 12 weeks with cracks and delamination similar to the damaged areas observed in the in-service POL tanks. This suggests that a combination of a high temperature and high humidity over a period of time is necessary to completely hydrolyse the coating. This is reinforced when the visual appearances between a fresh sample and a sample exposed for 12 weeks in the dry environment within the

*Figure 7. Sample after 4 weeks hydrolysis at 80°C and 100%RH*

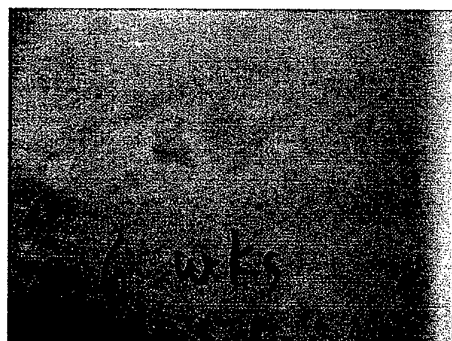
*Figure 8. Sample after 6 weeks hydrolysis at 80°C and 100%RH*

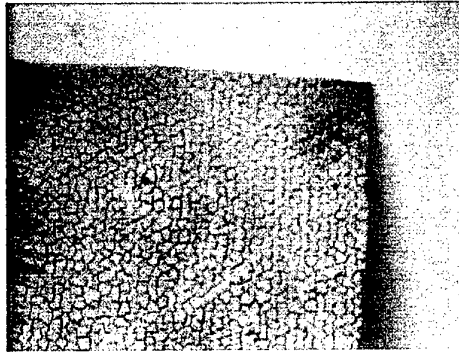
*Figure 9. Sample after 12 weeks hydrolysis at 80°C and 100%RH*

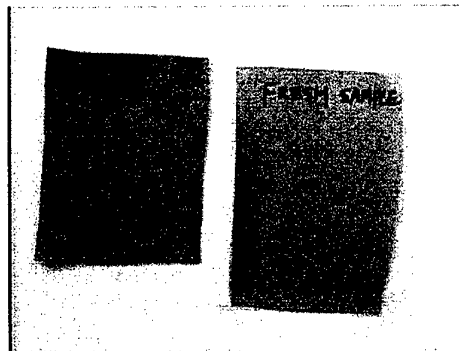
incubator are compared. As seen in Figure 10 there is little difference between the unexposed and exposed specimens, with no evidence of cracking or hardening of the coating. As no degradation of the coating was visible it was concluded that the coating is not susceptible to thermal degradation up to a temperature of 80°C.

*Figure 10. Sample after 10 weeks dry exposure at 80°C*

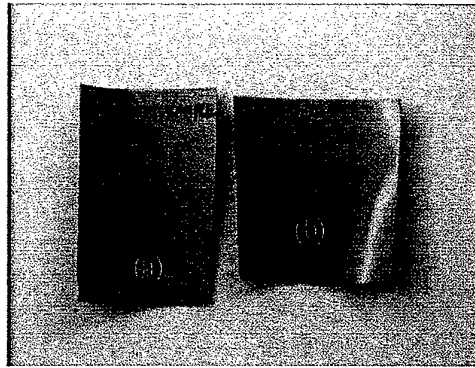
After immersion in diesel fuel for 3 weeks the samples showed a slight visible colour change (Figure 11). No cracks or delamination could be detected.

Figure 11. Unexposed coated fabric and coated fabric sample after 3 weeks immersion in diesel fuel (a) unexposed, (b) after immersion in diesel fuel
